# HDD drives fuel line for BP

UEA was recently contracted by AJ Lucas on behalf of BP Australia to install 345 m of 16 inch steel pipeline under the open channel and port access road at Elizabeth Street, Carrington near Newcastle in New South Wales.

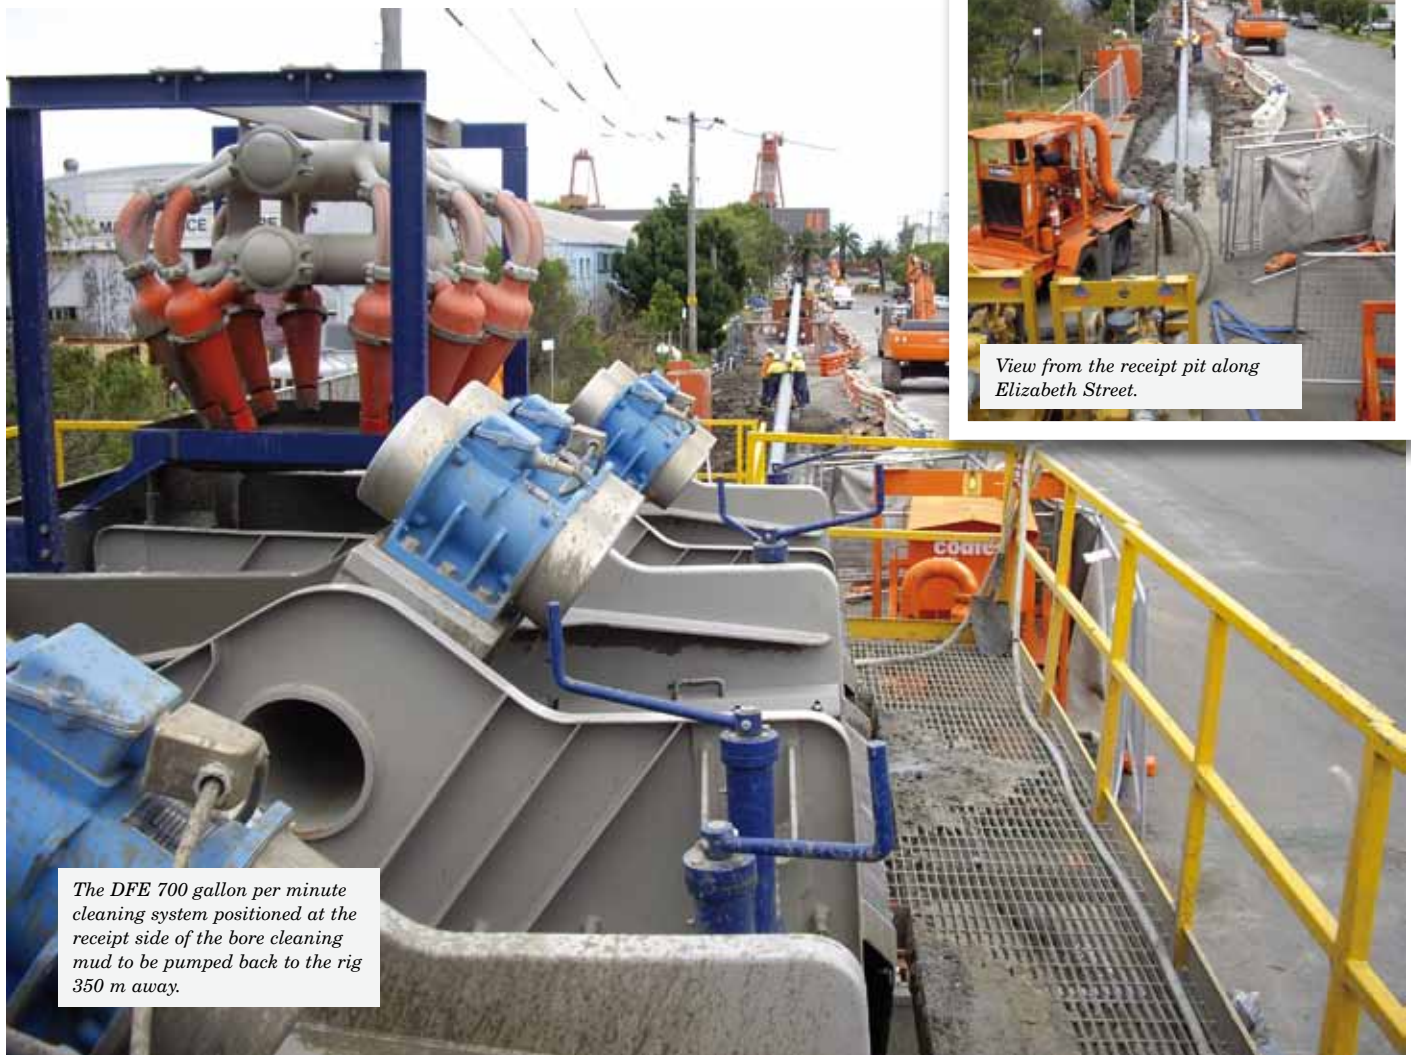
*The DFE 700 gallon per minute cleaning system positioned at the receipt side of the bore cleaning mud to be pumped back to the rig 350 m away.*

Come the New Year and completion of prior commitments, UEA mobilised its D300x500 rig and DFE 700 gallon per minute cleaning system to undertake reaming and installation of the 345 m, 16 inch main. Once set up and ready to wash over the drill string maintaining the bore hole, further site constraints delayed works until a closure of the port access road could be agreed in order to string out the pipe for pullback.

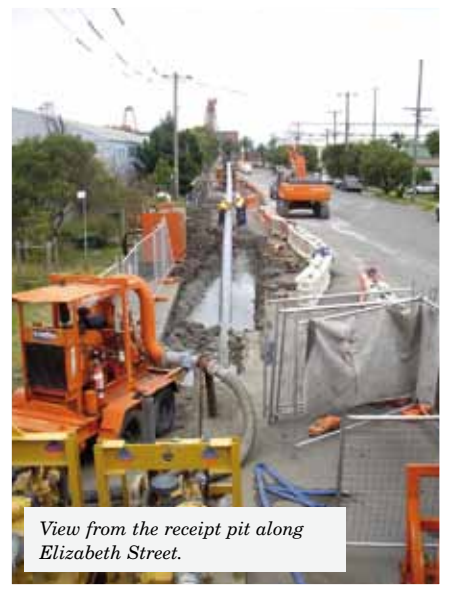
*View from the receipt pit along Elizabeth Street.*

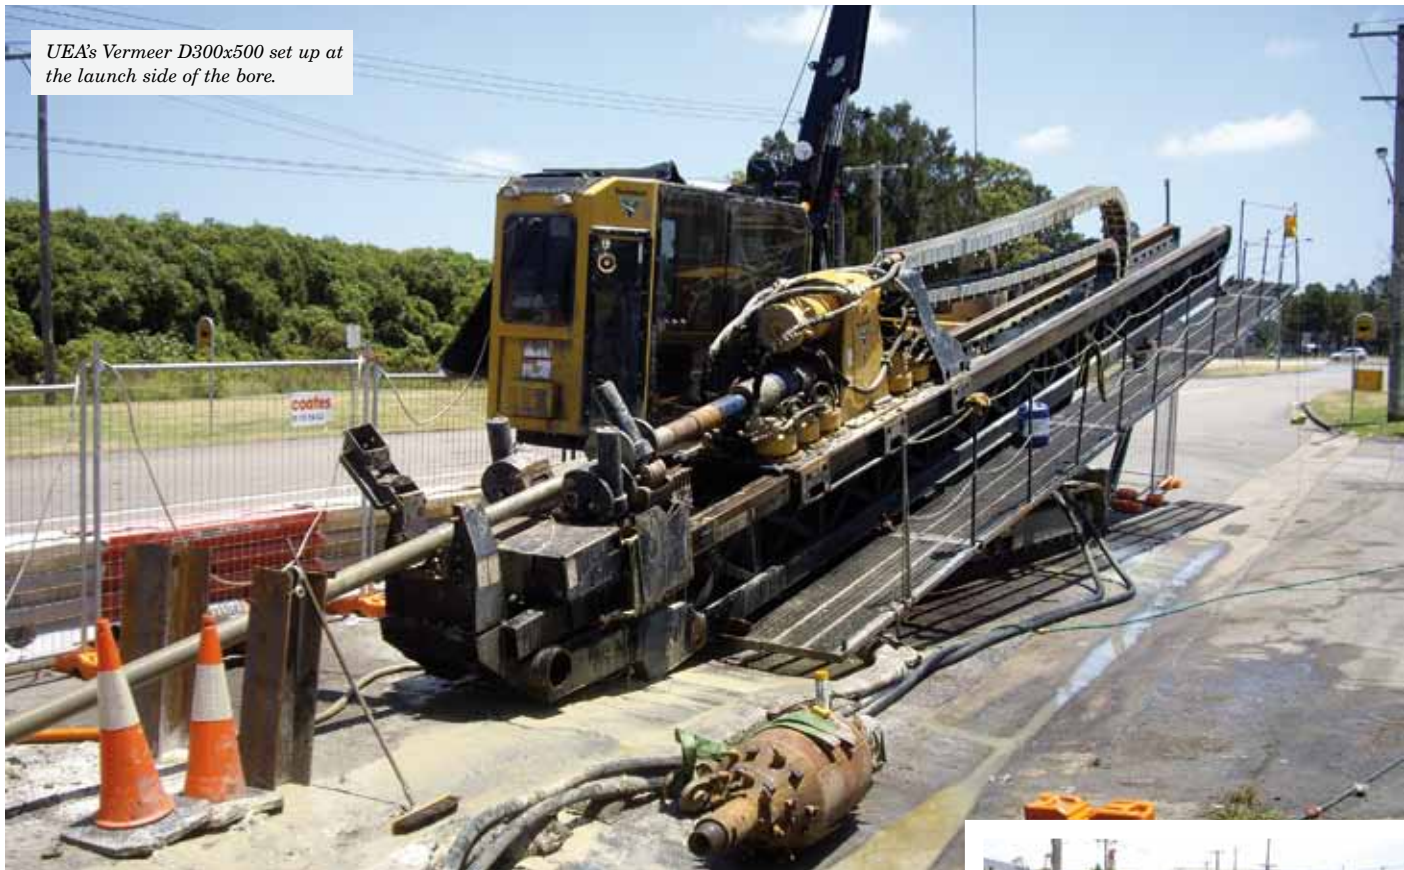
UEA's Vermeer D300x500 set up at the launch side of the bore.

unable to mobilise its 136 tonne Vermeer D300x500 rig until the New Year. A decision was made to pull in a smaller drill string to enable washing over once remobilised.

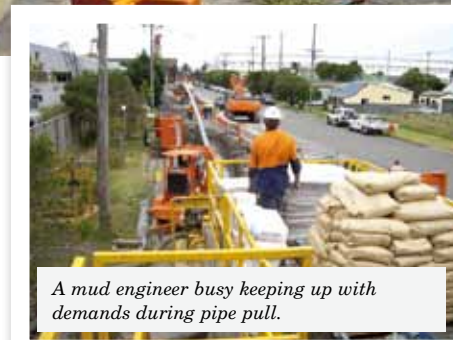
A mud engineer busy keeping up with demands during pipe pull.

A 750 mm open reamer was utilised for the pre-reaming pass in conjunction with a comprehensive mud program designed to carry out solids and help maintain hole stability in the sand. The bore was surprisingly stable with returns maintained for 90 per cent of the ream, a testament to the importance of good mud in these ground conditions.
